NIST NCSTAR 1A

**Federal Building and Fire Safety Investigation of the
World Trade Center Disaster**

Final Report on the Collapse of World Trade Center Building 7

August, 2008

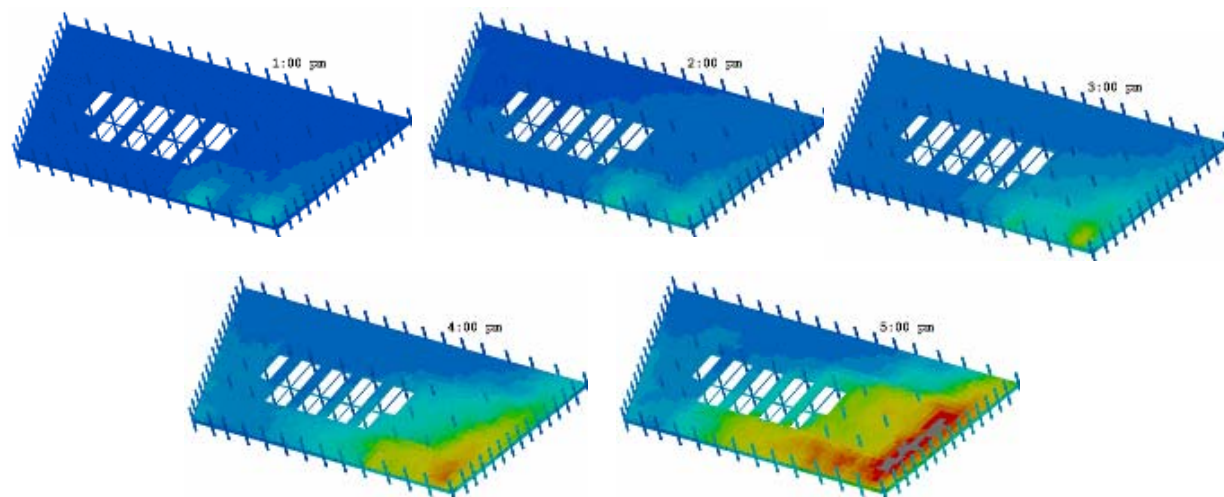
Figure 3–7 shows the calculated heating of the structural steel on the lower 16 floors of WTC 7 for the Case B temperatures from the fire simulation. The floor slabs have been removed from the figure for clarity. Figure 3–8 is a typical rendition of the calculated heating of the top of a floor slab as a result of the Case B fire.

Figure 3–8. Computed temperature distribution (°C) in the top layer of the concrete slab of Floor 12 at five different instants in time.
